MIDDLE TANA CATCHMENT

MINISTRY OF WATER SANITATION AND IRRIGATION

LAND DEGRADATION ASSESSMENT REPORT

2025

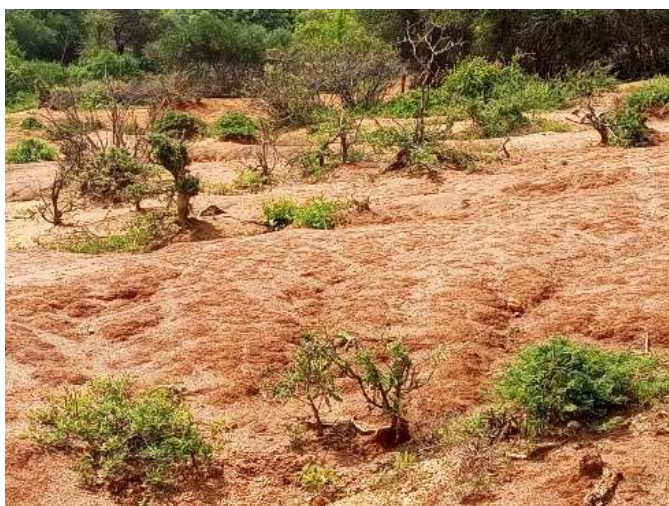
Figure 2 Photo from Mikwa Village field observation

Major Degrading factors (Type); e.g., Soil erosion, sedimentation, Biological, chemical, leaching, physical structural disturbances etc.	Soil erosion
Drivers and agents of the Degrading factors; e.g. Runoff water, Chemical use, poor agriculture practice, overgrazing, deforestation, mining and construction	Runoff water, overgrazing
General Comments: Note down any other useful information to support the above observations e.g. • Very sparse tree population and terrace farming • Bare land with extended rocky nature • Densely stoniness with disappearing grasses, Reducing soil nutrient composition, presence of harmful chemicals on the land	Very sparse tree population
Suggested mitigation measures and their viability	Water retention terraces Proper disposal of runoff water Check dams and water harvesting
Opportunities for implementing mitigation measures -Water resources and other natural resources, population, Land tenure, culture, social economic practices etc.	Sustainable water harvesting methods Sustainable tree harvesting

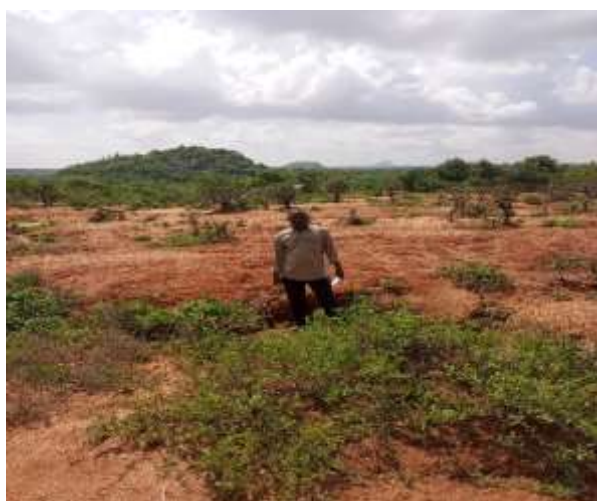
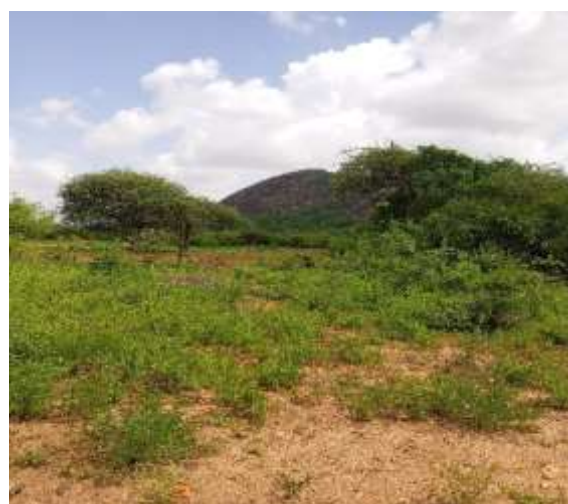
Figure 3 Photos from Kitwenye Village field Observation

Experienced changes:	
Major Degrading factors (Type); e.g., Soil erosion, sedimentation, Biological, chemical, leaching, physical structural disturbances etc.	Soil erosion Physical structural disturbances
Drivers and agents of the Degrading factors; e.g. Runoff water, Chemical use, poor agriculture practice, overgrazing, deforestation, mining and construction	Runoff water, over grazing
General Comments: Note down any other useful information to support the above observations e.g. • Very sparse tree population and terrace farming • Bare land with extended rocky nature • Densely stoniness with disappearing grasses, Reducing soil nutrient composition, presence of harmful chemicals on the land	Very sparse tree population
Suggested mitigation measures and their viability	Construction of farm ponds, terracing, selective tree harvesting
Opportunities for implementing mitigation measures -Water resources and other natural resources, population, Land tenure, culture, social economic practices etc.	Farm pond construction Sustainable agriculture practices Sustainable land use management

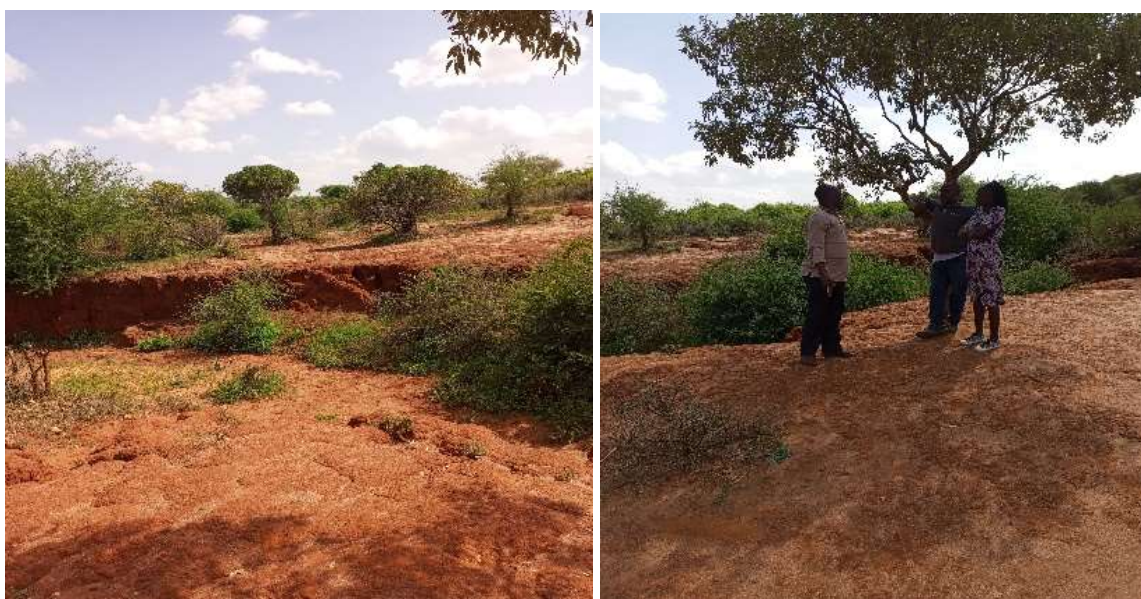
Figure 7 Photos from Kaliani kwa Kamakya Primary- Kaliani Village field observation

Major Degrading factors (Type); e.g., Soil erosion, sedimentation, Biological, chemical, leaching, physical structural disturbances etc.	Soil erosion, physical structural disturbances
Drivers and agents of the Degrading factors; e.g. Runoff water, Chemical use, poor agriculture practice, overgrazing, deforestation, mining and construction	Runoff water, poor agriculture practice, overgrazing
General Comments: Note down any other useful information to support the above observations e.g. • Very sparse tree population and terrace farming • Bare land with extended rocky nature • Densely stoniness with disappearing grasses, Reducing soil nutrient composition, presence of harmful chemicals on the land	Very sparse tree population
Suggested mitigation measures and their viability	Construction of gulley's, check dams, cut off drain, gulley control and sand dams
Opportunities for implementing mitigation measures -Water resources and other natural resources, population, Land tenure, culture, social economic practices etc.	Man power

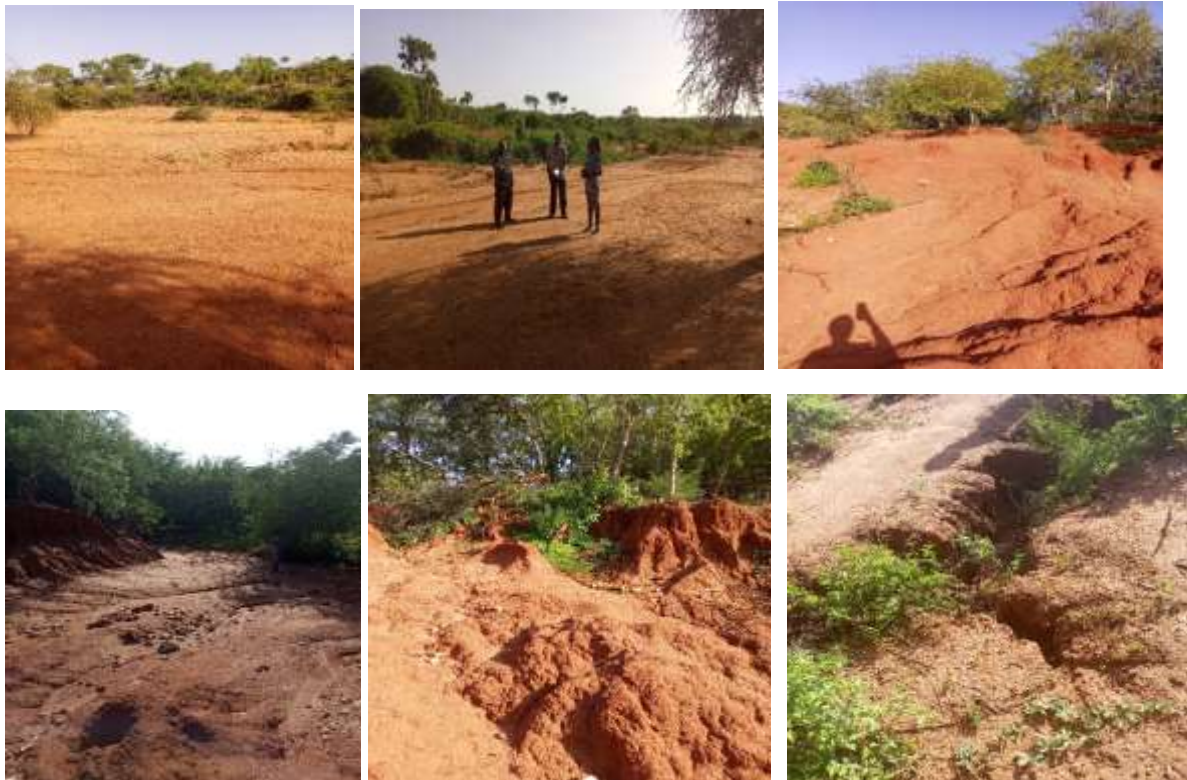
Figure 8 Photos from Manzuvu area – Mivukoni Village field observation

Major Degrading factors (Type); e.g., Soil erosion, sedimentation, Biological, chemical, leaching, physical structural disturbances etc.	Soil erosion
Drivers and agents of the Degrading factors; e.g. Runoff water, Chemical use, poor agriculture practice, overgrazing, deforestation, mining and construction	Runoff water, overgrazing, poor agriculture practice
General Comments: Note down any other useful information to support the above observations e.g. • Very sparse tree population and terrace farming • Bare land with extended rocky nature • Densely stoniness with disappearing grasses, Reducing soil nutrient composition, presence of harmful chemicals on the land	Very sparse tree population
Suggested mitigation measures and their viability	Construction of earth dams, terracing, fruit trees, boreholes and sand dams
Opportunities for implementing mitigation measures -Water resources and other natural resources, population, Land tenure, culture, social economic practices etc.	Land use management Labor Solar energy

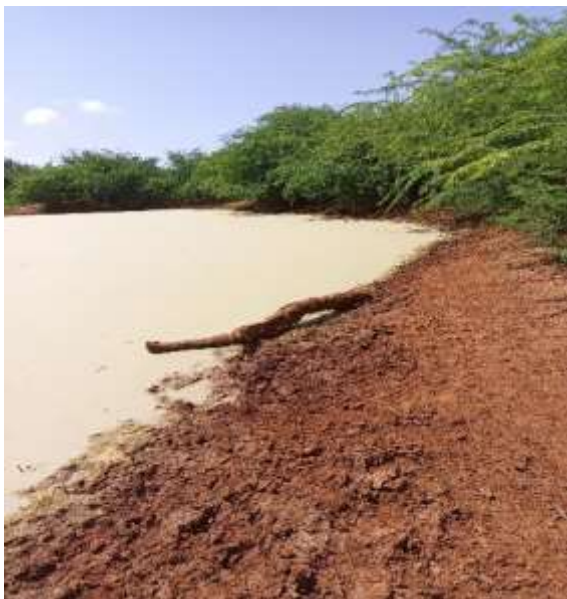
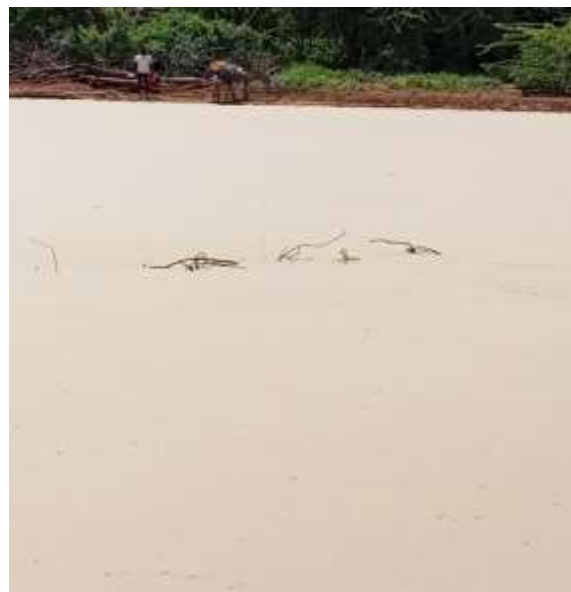
Figure 11 Photos from Kwamomba dam field observation

Agriculture, Forest, Grassland, Shrub land, Wetland, Bare areas, Settlement and water Land Management Experienced changes:	Shrub land, bare areas
Major Degrading factors (Type); e.g., Soil erosion, sedimentation, Biological, chemical, leaching, physical structural disturbances etc.	Soil erosion
Drivers and agents of the Degrading factors; e.g. Runoff water, Chemical use, poor agriculture practice, overgrazing, deforestation, mining and construction	Runoff water, poor agriculture practice, overgrazing
General Comments: Note down any other useful information to support the above observations e.g. • Very sparse tree population and terrace farming • Bare land with extended rocky nature • Densely stoniness with disappearing grasses, Reducing soil nutrient composition, presence of harmful chemicals on the land	Very sparse tree population Bare land
Suggested mitigation measures and their viability	Sustainable agriculture practices Land use management Tree planting

Opportunities for implementing mitigation measures -Water resources and other natural resources, population, Land tenure, culture, social economic practices etc.

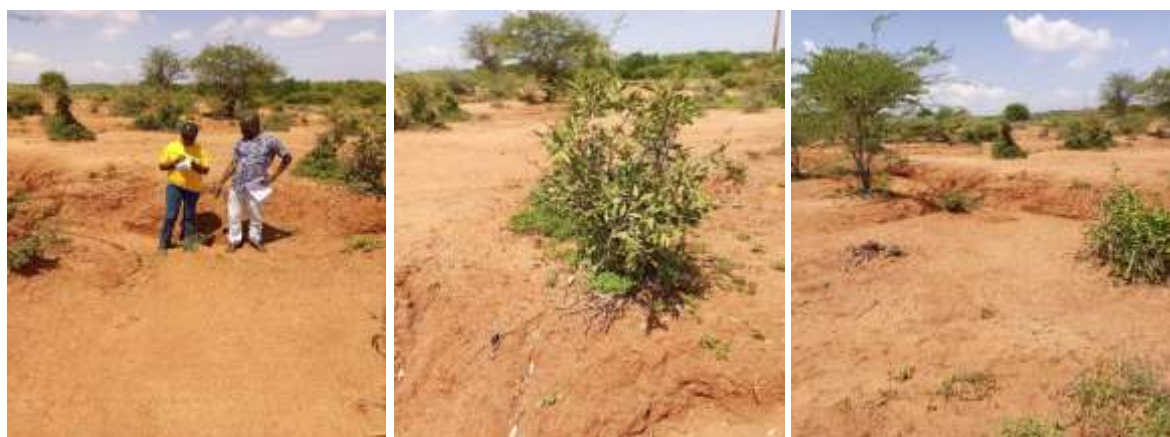
Figure 12 Photos from Osweni (near market) field observation

Land use: Vegetation Cover – Sample descriptions planted e.g. aquatic, scattered, tall grasses Plantations; Cropped land, seasonal/perennial, exotic tree e.g. eucalyptus etc. Land use type: Agriculture, Forest, Grassland, Shrub land, Wetland, Bare areas, Settlement and water Land Management Experienced changes:	Scattered, seasonal perennial Agriculture
Major Degrading factors (Type); e.g., Soil erosion, sedimentation, Biological, chemical, leaching, physical structural disturbances etc.	Soil erosion
Drivers and agents of the Degrading factors; e.g. Runoff water, Chemical use, poor agriculture practice, overgrazing, deforestation, mining and construction	Runoff water, poor agriculture practice
General Comments: Note down any other useful information to support the above observations e.g. • Very sparse tree population and terrace farming • Bare land with extended rocky nature • Densely stoniness with disappearing grasses, Reducing soil nutrient composition, presence of harmful chemicals on the land	Reducing soil nutrient composition

Suggested mitigation measures and their viability	Sustainable agriculture practices, tree planting
Opportunities for implementing mitigation measures -Water resources and other natural resources, population, Land tenure, culture, social economic practices etc.

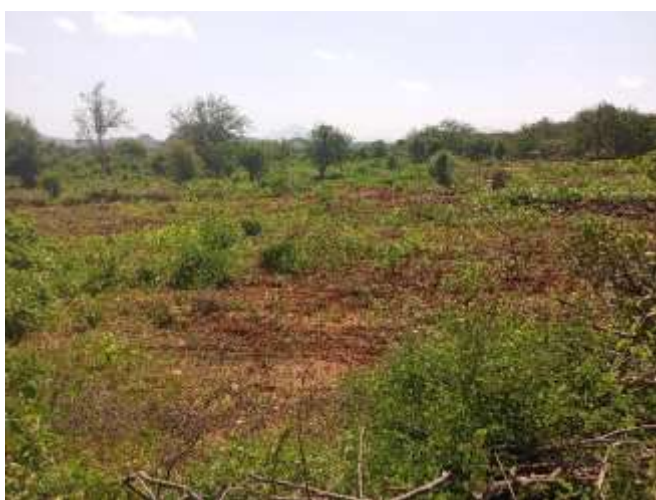
Figure 13 Photo from Kathangachini field observation

Land use: Vegetation Cover – Sample descriptions planted e.g. aquatic, scattered, tall grasses Plantations; Cropped land, seasonal/perennial, exotic tree e.g. eucalyptus etc. Land use type: Agriculture, Forest, Grassland, Shrub land, Wetland, Bare areas, Settlement and water Land Management Experienced changes:	Scattered, cropped land, seasonal/perennial
Major Degrading factors (Type); e.g., Soil erosion, sedimentation, Biological, chemical, leaching, physical structural disturbances etc.	Soil erosion
Drivers and agents of the Degrading factors; e.g. Runoff water, Chemical use, poor agriculture practice, overgrazing, deforestation, mining and construction	Runoff water Poor agricultural practices, deforestation
General Comments: Note down any other useful information to support the above observations e.g. • Very sparse tree population and terrace farming • Bare land with extended rocky nature • Densely stoniness with disappearing grasses, Reducing soil nutrient composition, presence of harmful chemicals on the land	Reducing soil nutrient composition Very sparse tree population

Suggested mitigation measures and their viability	Tree planting Sustainable land use management
Opportunities for implementing mitigation measures -Water resources and other natural resources, population, Land tenure, culture, social economic practices etc.

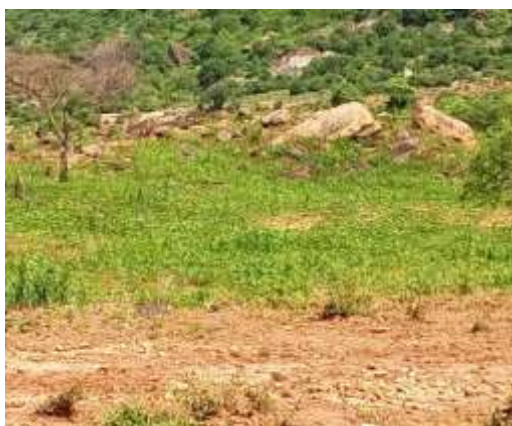
Figure 14 Photo from Kathangachini field observation

Topography: Slope Steepness • Flat • Gentle flat • Gentle slope • Steep slope • Very steep slope	Gentle flat
Slope Length • Very long • Long • Medium • Short • Very Short NB: Describe general terrain-Slope part of the hill, river valley	Medium
Vegetation (Type): Forest Agriculture - Perennial, Seasonal Grassland Woodland Bare land, Water Condition (Vegetation health) Very good, Good, Normal, Poor, Very Poor. Status – natural vegetation or planted Experienced changes	Perennial seasonal woodland Normal Natural vegetation
Population Human Settlement Estimated population coverage based on available data and/or your field of view e.g. homestead counts as based on visualized number of houses Livestock: Cows, goats and sheep/Livelihood activities/social economic aspects.	
Land use: Vegetation Cover – Sample descriptions planted e.g. aquatic, scattered, tall grasses Plantations; Cropped land, seasonal/perennial, exotic tree e.g. eucalyptus etc. Land use type: Agriculture, Forest, Grassland, Shrub land, Wetland, Bare areas, Settlement and water Land Management	Scattered, seasonal/perennial, cropped land Agriculture

Experienced changes:	Tree harvesting
Major Degrading factors (Type); e.g., Soil erosion, sedimentation, Biological, chemical, leaching, physical structural disturbances etc.	Soil erosion
Drivers and agents of the Degrading factors; e.g. Runoff water, Chemical use, poor agriculture practice, overgrazing, deforestation, mining and construction	Runoff water, poor agriculture practice, deforestation
General Comments: Note down any other useful information to support the above observations e.g. • Very sparse tree population and terrace farming • Bare land with extended rocky nature • Densely stoniness with disappearing grasses, Reducing soil nutrient composition, presence of harmful chemicals on the land	Reducing soil nutrient composition Very sparse tree population
Suggested mitigation measures and their viability	Tree planting Sustainable agriculture practices
Opportunities for implementing mitigation measures -Water resources and other natural resources, population, Land tenure, culture, social economic practices etc.

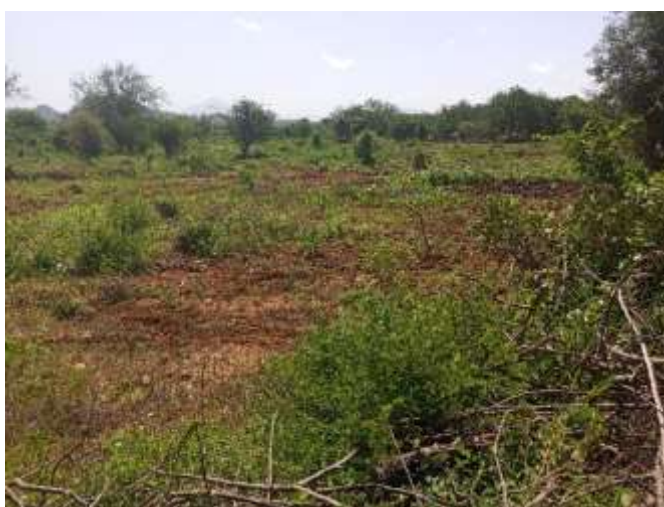
Figure 15 Photo from Kathangachini field observation

Topography: Slope Steepness • Flat • Gentle flat • Gentle slope • Steep slope • Very steep slope	Gentle flat
Slope Length • Very long • Long • Medium • Short • Very Short NB: Describe general terrain-Slope part of the hill, river valley	Medium
Vegetation (Type): Forest Agriculture - Perennial, Seasonal Grassland Woodland Bare land, Water Condition (Vegetation health) Very good, Good, Normal, Poor, Very Poor. Status – natural vegetation or planted Experienced changes	Perennial, seasonal woodland Normal Natural vegetation
Population Human Settlement Estimated population coverage based on available data and/or your field of view e.g. homestead counts as based on visualized number of houses Livestock: Cows, goats and sheep/Livelihood activities/social economic aspects.	
Land use: Vegetation Cover – Sample descriptions planted e.g. aquatic, scattered, tall grasses Plantations; Cropped land, seasonal/perennial, exotic tree e.g. eucalyptus etc. Land use type: Agriculture, Forest, Grassland, Shrub land, Wetland, Bare areas, Settlement and water Land Management	Scattered, cropped land, seasonal/perennial m Agriculture, forest Tree harvesting

Experienced changes:	
Major Degrading factors (Type); e.g., Soil erosion, sedimentation, Biological, chemical, leaching, physical structural disturbances etc.	Soil erosion
Drivers and agents of the Degrading factors; e.g. Runoff water, Chemical use, poor agriculture practice, overgrazing, deforestation, mining and construction	Runoff water, poor agriculture practices, deforestation
General Comments: Note down any other useful information to support the above observations e.g. • Very sparse tree population and terrace farming • Bare land with extended rocky nature • Densely stoniness with disappearing grasses, Reducing soil nutrient composition, presence of harmful chemicals on the land	Reducing soil composition, very sparse tree population
Suggested mitigation measures and their viability	Tree planting Sustainable land use management Sustainable agricultural practices
Opportunities for implementing mitigation measures -Water resources and other natural resources, population, Land tenure, culture, social economic practices etc.

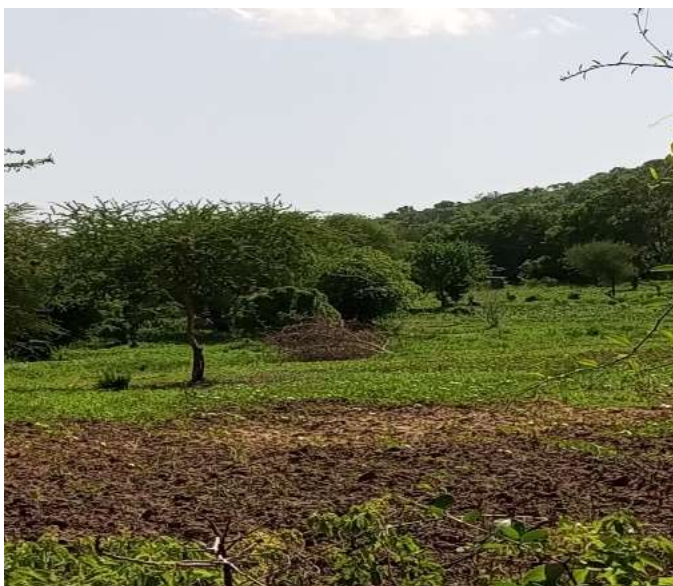
Figure 16 Photo from Gatunga field observation

Topography: Slope Steepness • Flat • Gentle flat • Gentle slope • Steep slope • Very steep slope	Gentle slope to steep slope
Slope Length • Very long • Long • Medium • Short • Very Short NB: Describe general terrain-Slope part of the hill, river valley	Medium to long Slope part of the hill
Vegetation (Type): Forest Agriculture - Perennial, Seasonal Grassland Woodland Bare land, Water Condition (Vegetation health) Very good, Good, Normal, Poor, Very Poor. Status – natural vegetation or planted Experienced changes	Perennial, seasonal woodland Normal Natural vegetation
Population Human Settlement Estimated population coverage based on available data and/or your field of view e.g. homestead counts as based on visualized number of houses Livestock: Cows, goats and sheep/Livelihood activities/social economic aspects.	
Land use: Vegetation Cover – Sample descriptions planted e.g. aquatic, scattered, tall grasses Plantations; Cropped land, seasonal/perennial, exotic tree e.g. eucalyptus etc. Land use type: Agriculture, Forest, Grassland, Shrub land, Wetland, Bare areas, Settlement and water Land Management Experienced changes:	Cropped land, seasonal/perennial Agriculture

Major Degrading factors (Type); e.g., Soil erosion, sedimentation, Biological, chemical, leaching, physical structural disturbances etc.	Soil erosion
Drivers and agents of the Degrading factors; e.g. Runoff water, Chemical use, poor agriculture practice, overgrazing, deforestation, mining and construction	Runoff water, poor agriculture practices, deforestation
General Comments: Note down any other useful information to support the above observations e.g. • Very sparse tree population and terrace farming • Bare land with extended rocky nature • Densely stoniness with disappearing grasses, Reducing soil nutrient composition, presence of harmful chemicals on the land	Very sparse tree population, reducing soil nutrient composition
Suggested mitigation measures and their viability	Tree planting Sustainable land use management Sustainable agriculture practices
Opportunities for implementing mitigation measures -Water resources and other natural resources, population, Land tenure, culture, social economic practices etc.

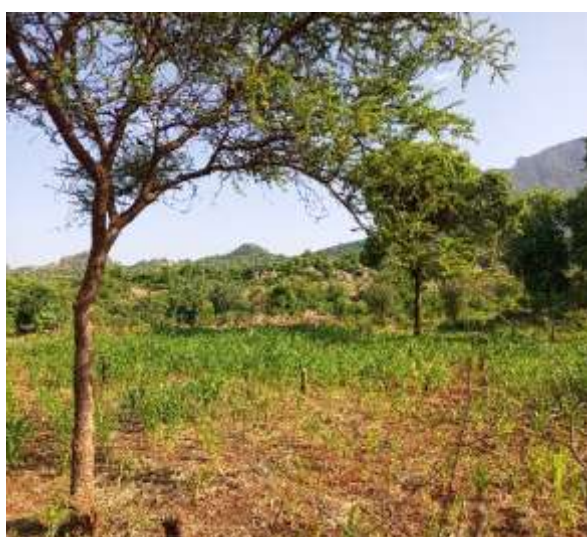
Figure 17 Photo from Chiakariga field observation

Topography: Slope Steepness • Flat • Gentle flat • Gentle slope • Steep slope • Very steep slope	Gentle slope
Slope Length • Very long • Long • Medium • Short • Very Short NB: Describe general terrain-Slope part of the hill, river valley	Medium to high
Vegetation (Type): Forest Agriculture - Perennial, Seasonal Grassland Woodland Bare land, Water Condition (Vegetation health) Very good, Good, Normal, Poor, Very Poor. Status – natural vegetation or planted Experienced changes	Perennial, seasonal grassland, woodland Normal Natural vegetation
Population Human Settlement Estimated population coverage based on available data and/or your field of view e.g. homestead counts as based on visualized number of houses Livestock: Cows, goats and sheep/Livelihood activities/social economic aspects.	
Land use: Vegetation Cover – Sample descriptions planted e.g. aquatic, scattered, tall grasses Plantations; Cropped land, seasonal/perennial, exotic tree e.g. eucalyptus etc. Land use type: Agriculture, Forest, Grassland, Shrub land, Wetland, Bare areas, Settlement and water Land Management Experienced changes:	Cropped land, seasonal/perennial

Major Degrading factors (Type); e.g., Soil erosion, sedimentation, Biological, chemical, leaching, physical structural disturbances etc.	Soil erosion Physical structural disturbances
Drivers and agents of the Degrading factors; e.g. Runoff water, Chemical use, poor agriculture practice, overgrazing, deforestation, mining and construction	Runoff water, mining and construction, poor agriculture practices, deforestation
General Comments: Note down any other useful information to support the above observations e.g. • Very sparse tree population and terrace farming • Bare land with extended rocky nature • Densely stoniness with disappearing grasses, Reducing soil nutrient composition, presence of harmful chemicals on the land	Very sparse tree population, reducing soil nutrient composition
Suggested mitigation measures and their viability	
Opportunities for implementing mitigation measures -Water resources and other natural resources, population, Land tenure, culture, social economic practices etc.

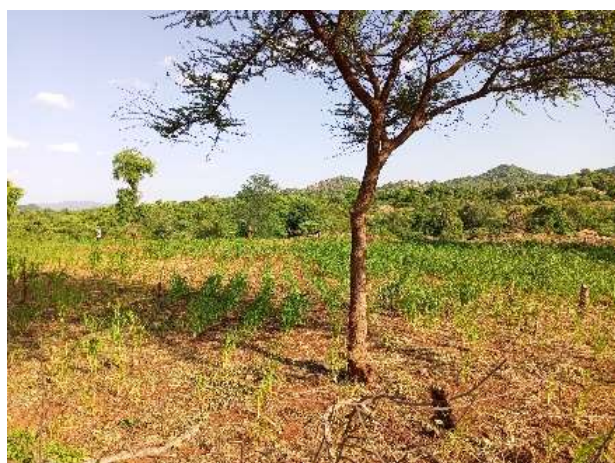
Figure 18 Photo from Chiakariga field observation

Topography: Slope Steepness • Flat • Gentle flat • Gentle slope • Steep slope • Very steep slope	Gentle slope
Slope Length • Very long • Long • Medium • Short • Very Short NB: Describe general terrain-Slope part of the hill, river valley	Medium to long
Vegetation (Type): Forest Agriculture - Perennial, Seasonal Grassland Woodland Bare land, Water Condition (Vegetation health) Very good, Good, Normal, Poor, Very Poor. Status – natural vegetation or planted Experienced changes	Perennial, seasonal grassland, woodland
Population Human Settlement Estimated population coverage based on available data and/or your field of view e.g. homestead counts as based on visualized number of houses Livestock: Cows, goats and sheep/Livelihood activities/social economic aspects.	
Land use: Vegetation Cover – Sample descriptions planted e.g. aquatic, scattered, tall grasses Plantations; Cropped land, seasonal/perennial, exotic tree e.g. eucalyptus etc. Land use type: Agriculture, Forest, Grassland, Shrub land, Wetland, Bare areas, Settlement and water Land Management Experienced changes:	Seasonal/ perennial, Agriculture, forest, grassland

Major Degrading factors (Type); e.g., Soil erosion, sedimentation, Biological, chemical, leaching, physical structural disturbances etc.	Soil erosion
Drivers and agents of the Degrading factors; e.g. Runoff water, Chemical use, poor agriculture practice, overgrazing, deforestation, mining and construction	Runoff water, poor agriculture practices
General Comments: Note down any other useful information to support the above observations e.g. • Very sparse tree population and terrace farming • Bare land with extended rocky nature • Densely stoniness with disappearing grasses, Reducing soil nutrient composition, presence of harmful chemicals on the land	Very sparse tree population Reducing soil nutrient composition
Suggested mitigation measures and their viability	Terracing Sustainable agricultural practices
Opportunities for implementing mitigation measures -Water resources and other natural resources, population, Land tenure, culture, social economic practices etc.

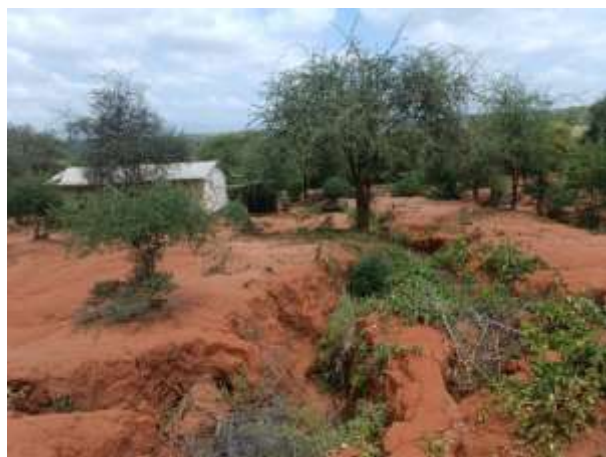
Surface runoff compounded by presence of steep slope and low infiltration was main source of degradation. Huge gullies were already formed threatening both the road and homestead nearby this site. The site was classified as hot spot and require interventions by installation of gabions on the huge gullies, construction of cutoff drains, check dams on road side water ways and planting tree. The opportunities to utilize for interventions includes partnering with local communities and county government institution such as department of agriculture.

Figure 20: Kanguu with rills and gullies (Lat 0°56'43.8" Long 38°5'52.4" E and alt 926m)

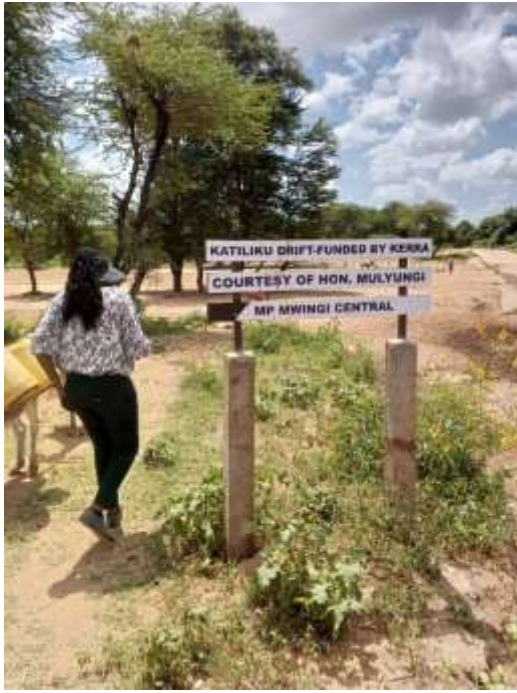
Extensive depositions of silt and sand in the river bed was evident and was the probable cause of river diversion. This is an indication of extensive land degradation taking place in the upstream. The proposed solution to the problem is interventions upstream to control excessive surface runoff by use of terraces, retention ditches, check dams, planting of cover crops and trees. And in the downstream, extraction of sand, river training and opening up off the blocked river courses should be encouraged. These mitigation measures could exploit collaboration with relevant institutions like agriculture and water in county government and local community.

*Figure 21: River changed the course
38° 10' 40.4"E and Alt 761m)*

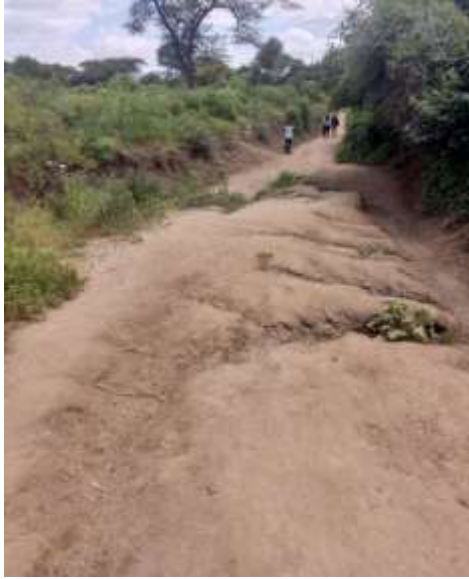
*Figure 23: Road turned into a river course
21.9"E alt 748m)*

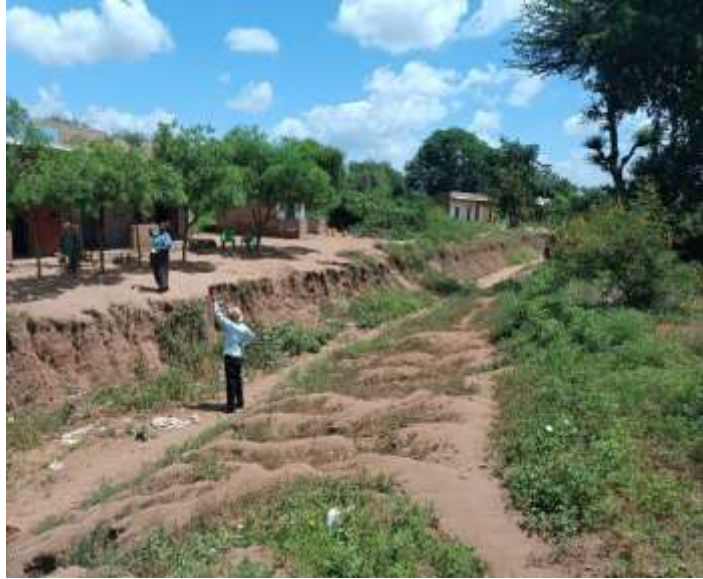
Figure 24: Huge gully dividing market center (Lat 1°2'40.4"S Long 38°11'

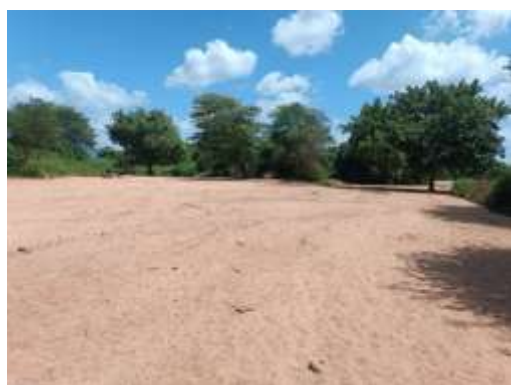
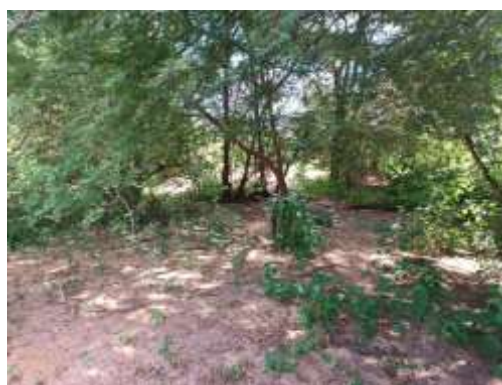
Figure 25: Ilekya River changed its main course (Lat 1° 4' 52.2" S Long 38° 11' 22.6" E alt. 725m)

The mitigation measures suggested included establishing irrigation scheme, construction of sand dam and weirs (intake). Opportunities available to achieve the suggested mitigations includes collaboration with county government institutions such as water and agriculture.

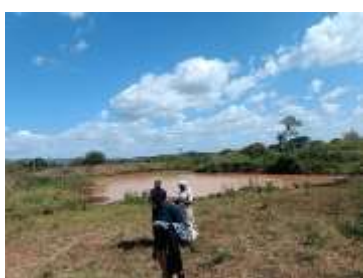
The soils in the area were clay loam suitable for holding water in the water pan. Low land degradation was observed and the ground had a good grass cover. The general topography of the area was gentle flat with wooded grassland and shrubs vegetation. This area was identified as a bright spot.

Figure 26: Private water pan site (Lat 1° 5' 5.7"S, Long 38° 12' 14"E, Alt 710m)

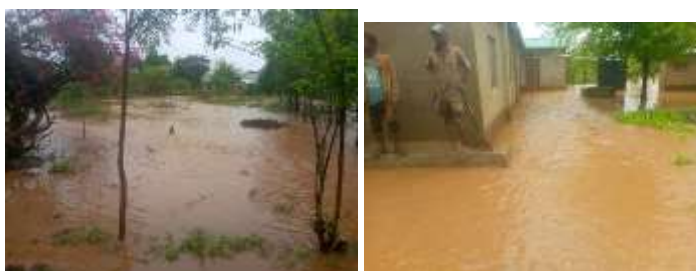
Figure 27: Photos taken during river spreading over Kaui village

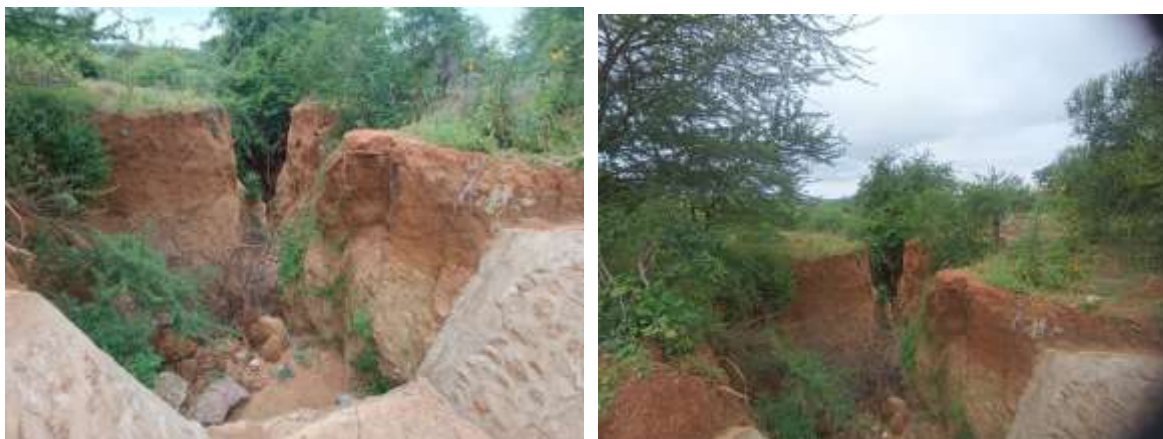
This site was marked as potential hot spot.

Figure 31: Gully due to improper disposal of road side water (Lat 0° 46' 29.6"s Long 38° 5' 36.2" E alt 992m)

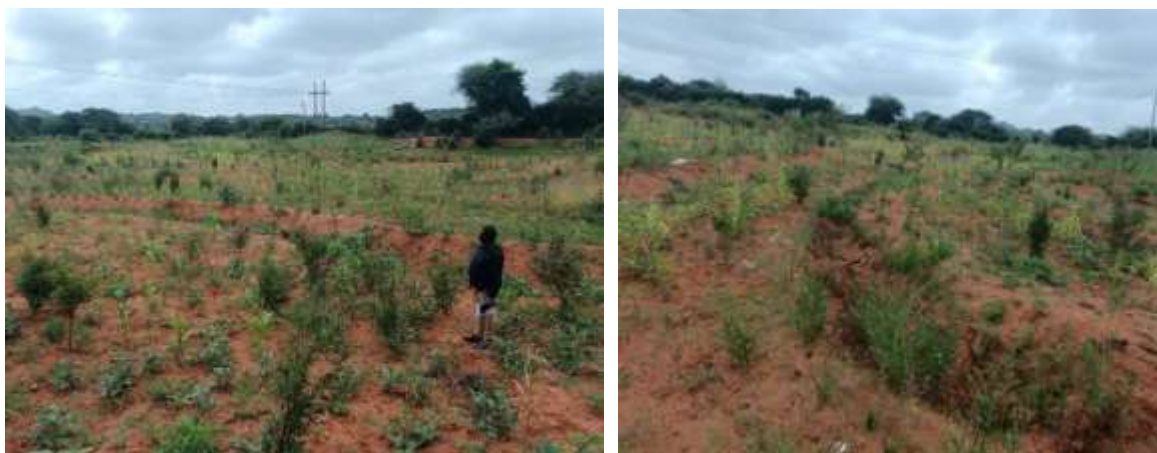
This area was marked as a bright spot because degradation had been controlled by land reclamation structures and a homestead had been constructed on the site. Land productivity was improving.

Figure 32: Reclamation of a former quarry site (Lat 0° 43' 43"S Long 38° 5' 23'S Alt 1028m)

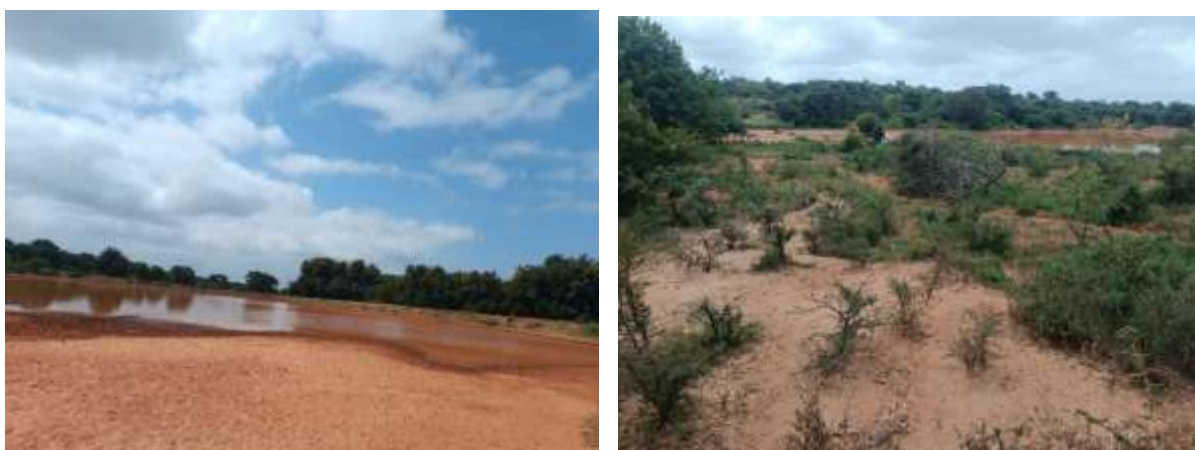
Figure 33: Kisolet Earth Dam (Lat 0° 43' 52.1"s long 38° 5' 25.8"E Alt 999M)

The area had sandy loam soils with very little organic matter. The land surfaces in the area nearby had patches of bare land. Vegetation of the area was scattered thorny shrubs and few trees which were natural. The general topography was gently sloping with long slope lengths estimated to about 300m. Sheet erosion was prevalent with some rills already formed but no gully was cited. Catchment management initiatives were proposed up stream which included terracing, erecting check dams, planting trees and reseeding with grasses to prevent silting of the dam. The earth dam should also be desilted. Opportunities available included collaboration with county departments of water and agriculture plus local communities for suitable interventions.

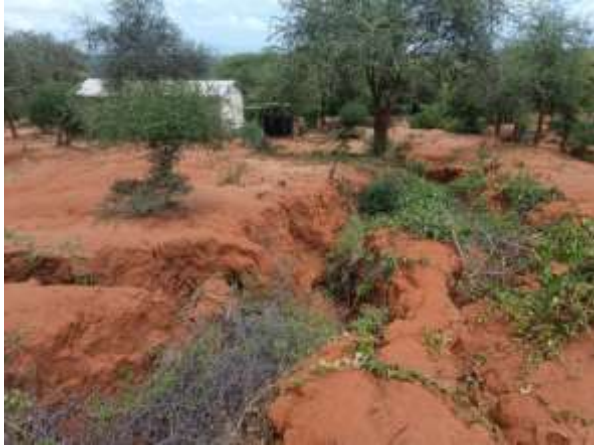
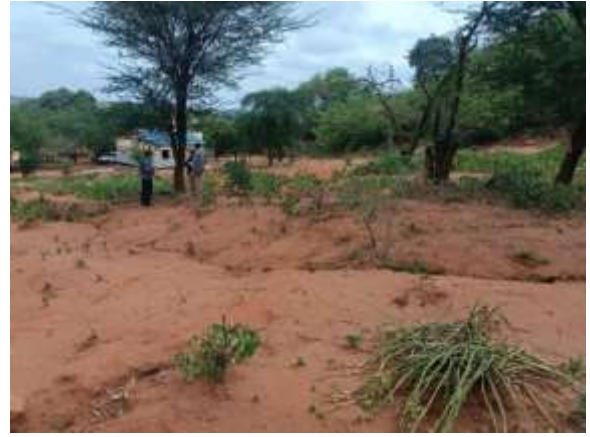
Figure 34: Mwambui Ass chief's Office (Lat 0° 44' 53.4"S Long 38° 3' 9.2"E alt 957M)

This area was marked as a hot spot. If no actions will be taken, soil erosion threatens destroying both the chief's office, and the nearby dispensary with further destruction of farms downstream.

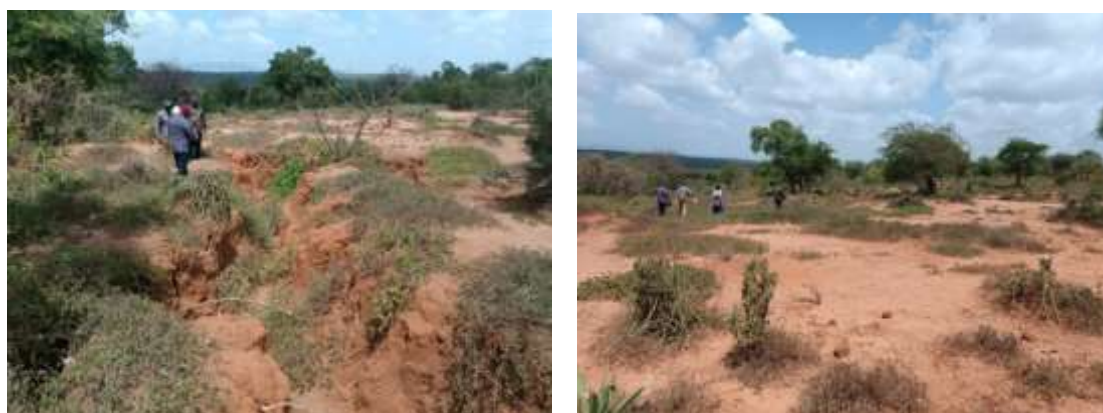
Figure 35: Kisole market (Lat 0° 44' 49.9"S long 38° 4' 30.5' E Alt 1000m)

This area was marked as a hot spot requiring rehabilitation. Collaboration between the local community, local NGO's and the county government will enable realization of rehabilitation efforts.

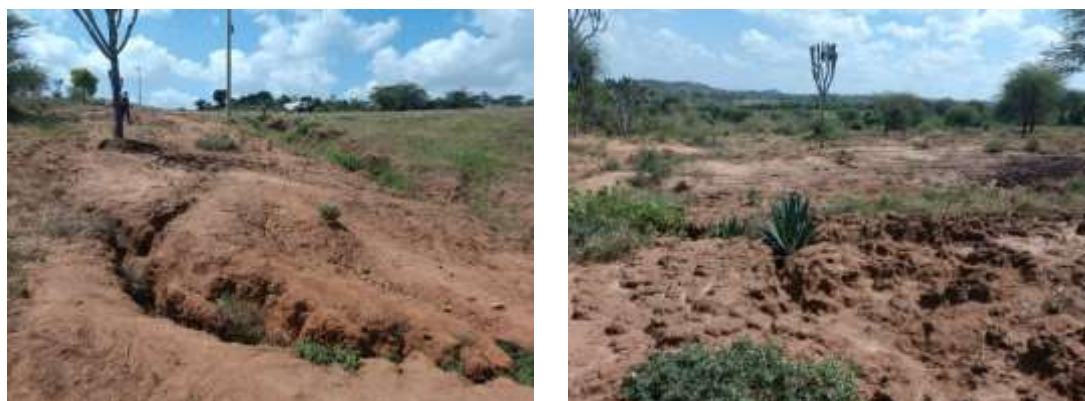
Figure 36: Bondoni Site (Lat 0° 58' 7.6"S Long 38° 0' 23.4"E Alt 1025M)

Land degradation could worsen with combined aspects of aridity, denuded land and trampling of livestock. This area was marked as a potential hot spot. Proposed mitigation measures for this site were terraces, check dams and planting of trees (sisal).

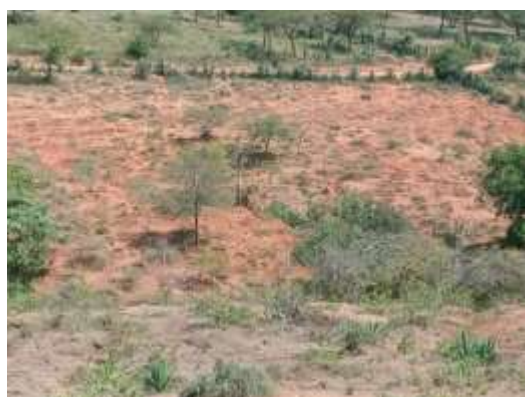
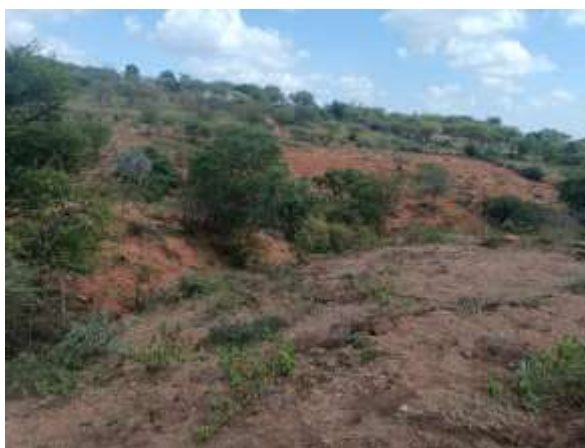
Figure 37: Bondoni GEBC Church (Lat 0° 59' 20.5"S Long 37° 58' 53"E Alt 1204M)

Major degradation was caused by soil erosion whose main drivers / agents was surface run off and aggravated by arid weather conditions. The area exhibited reducing soil nutrients. Proposed mitigation measures for this area include; retention ditches, terraces and tree planting (sisal). This area was marked as a potential hot spot. Collaboration of the County government with local community in rehabilitation efforts will curb this menace.

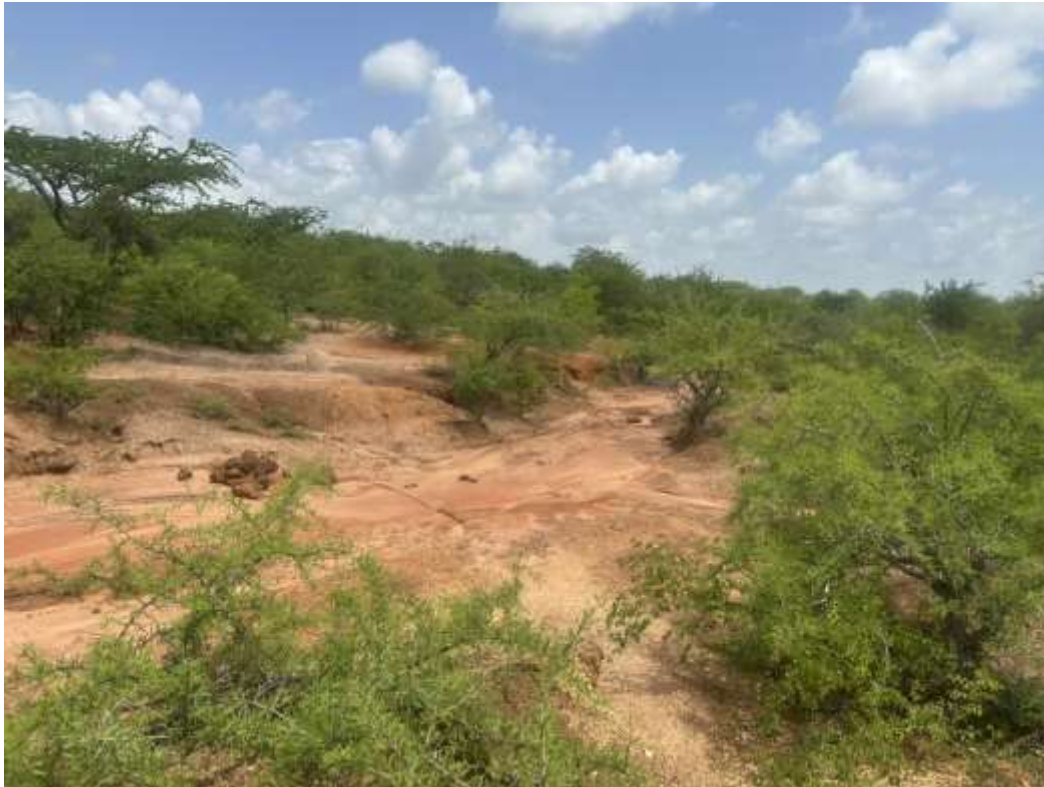
Yavwia village is in Mutha, a densely populated area in Kitui South Constituency. It has a tropical savannah climate and an average annual rainfall of 251-300mm. The area has a brown, sandy soil type with medium degradation, evidenced by gully erosion due to runoff water. The terrain consists of gentle slopes with medium slope length. Vegetation is primarily seasonal shrubland with patches of cropland, though human settlement is sparse. Field observations indicated bare land with rocky terrain, sparse trees, and declining soil nutrients. Proposed mitigation measures included constructing check dams, terraces, and a water pan, leveraging available natural resources and land management opportunities.

Figure 38: Gulleys caused by runoff at Yavwia village

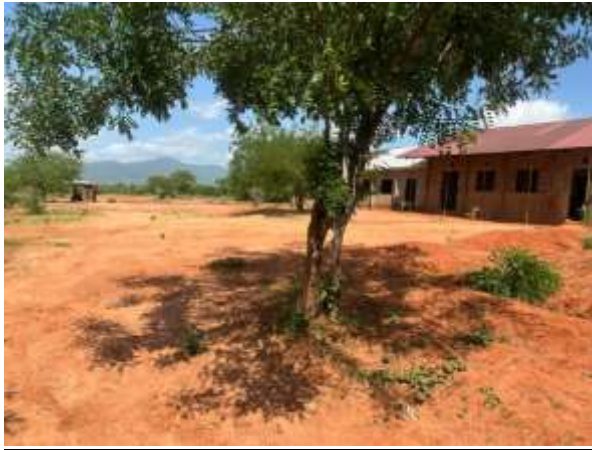
Figure 39a: Land degradation at Kivyuni Secondary School in Mathima Location Figure 2b: The Land degradation staff and local administration on site

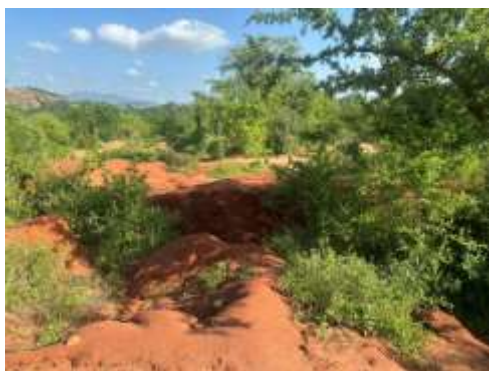
Figure 40: Deep Gully caused by runoff in Kenze Area

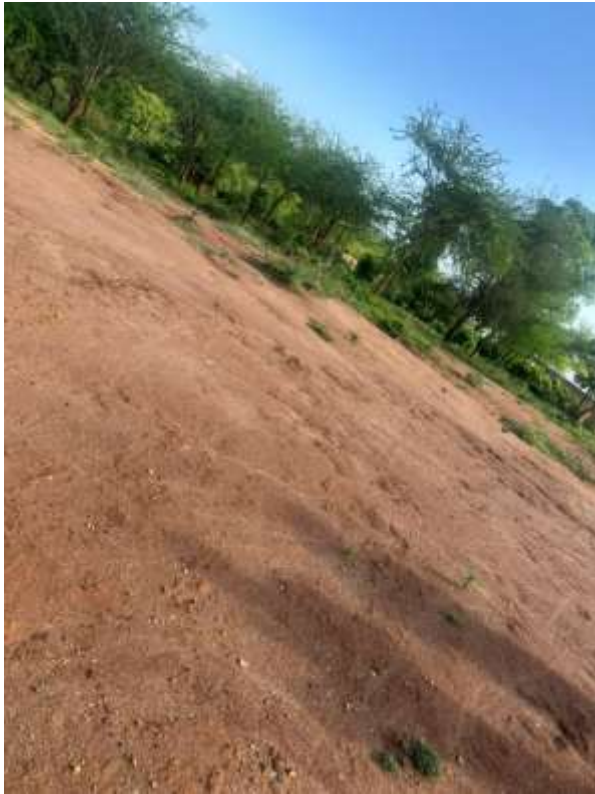
Figure 41: Run-off induced bare land with poor soil nutrients

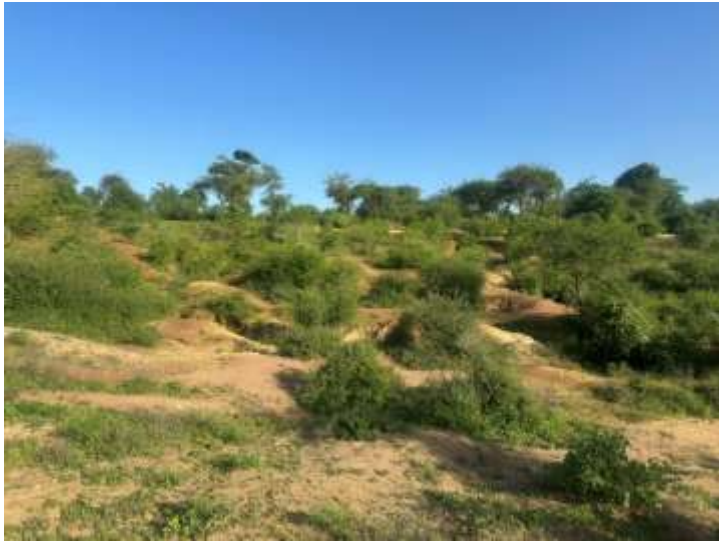
A site assessment was conducted in Wii location, Wii sub-location, Kyangulu village (Middle Tana, Kitui Central Constituency). The site, located at -1.19712 latitude, 37.96686 longitude, and 1385ft altitude, has brown, slightly degraded, sandy soil with gully erosion. Rainfall ranges from 300-350mm. The terrain consists of gentle, short slopes supporting moderate human settlement and seasonal shrubland with normal vegetation health. Land cover includes scattered trees, seasonal/perennial crops, and bare areas. The major degrading factor is soil erosion caused by runoff. A bare, rocky nature characterizes the area.
