**STATE DEPARTMENT FOR IRRIGATION**

**LAND RECLAMATION AND CLIMATE RESILIENCE**

**LAND DEGRADATION ASSESSMENT (LADA) REPORT  
TALEK SUBCATCHMENT – LOWER MARA**

**NOVEMBER 2024**

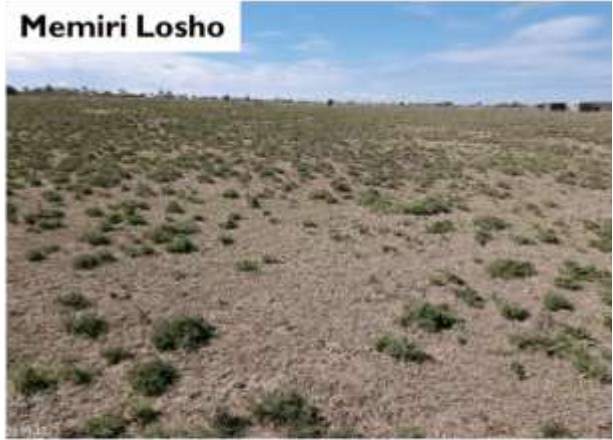
**Olelentia**

7	Olelemutia	around Olelemutia market	<ul style="list-style-type: none"> <li>• sparsely populated</li> <li>• lose black soil</li> </ul>	<ul style="list-style-type: none"> <li>• Livestock keeping</li> <li>• SMEs</li> </ul>	<ul style="list-style-type: none"> <li>• Rill and gully erosion</li> <li>• Overgrazing</li> </ul>	<ul style="list-style-type: none"> <li>• Gabion construction</li> <li>• Sustainable land management</li> </ul>

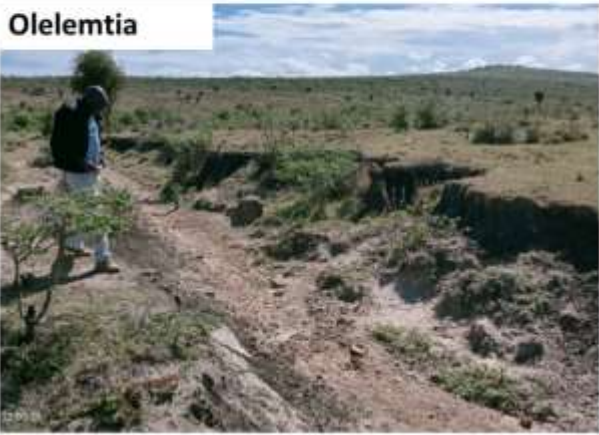
**Oliposimoru**

<ul style="list-style-type: none"> <li>• Rainwater water harvesting</li> <li>• Terracing</li> </ul>
8	Olposimoru	near Olposimoru market, Oldekesi sublocation, Nainkara ward, Narok west subcounty	<ul style="list-style-type: none"> <li>• Generally flat grassland with sparse shrubs and trees</li> <li>• Area experiencing increasing population</li> </ul>	<ul style="list-style-type: none"> <li>• Charcoal burning</li> <li>• SMEs</li> </ul>	<ul style="list-style-type: none"> <li>• Overgrazing</li> <li>• Tree cutting</li> </ul>	<ul style="list-style-type: none"> <li>• Sustainable Land Management</li> <li>• Rainwater harvesting</li> <li>• Terracing</li> </ul>
9	Suswa	Mount Suswa conservancy area: 1° 4' 35" S 36° 18' 22" E; Alt. 1645m a.s.l.	<ul style="list-style-type: none"> <li>• Grassland with scattered short shrubs</li> <li>• Sparse and scatter population on generally steep slopes.</li> </ul>	<ul style="list-style-type: none"> <li>• Livestock keeping</li> </ul>	<ul style="list-style-type: none"> <li>• Soil erosion</li> <li>• Overgrazing</li> </ul>	<ul style="list-style-type: none"> <li>• Gully healing/repair</li> <li>• Grass reseeding</li> <li>• Reforestation</li> <li>• Constructing check dams</li> <li>• Drains rerouting</li> </ul>

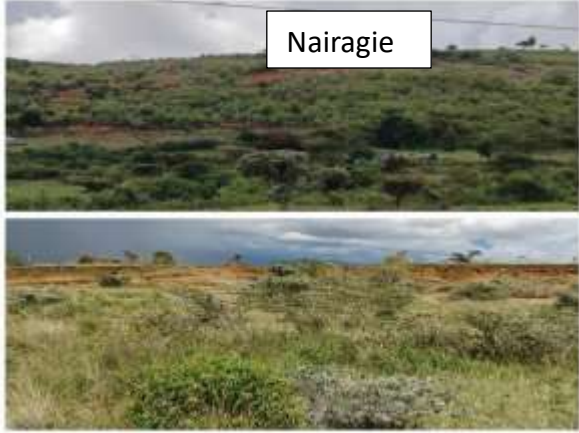
10	Nairagie Enkare	1° 5' 43" S 36° 10' 8" E Alt. 2000m a.s.l.	<ul style="list-style-type: none"> <li>• Steep to very steep slopes</li> <li>• Population is scarce except at the nearby town</li> <li>• Shrubs and short grasses and bare ground in some areas on the hills, cropped land at the foot of the hill</li> </ul>	<ul style="list-style-type: none"> <li>• Livestock keeping</li> <li>• Subsistence farming</li> </ul>	<ul style="list-style-type: none"> <li>• Deforestation</li> <li>• Soil Erosion / run-off</li> <li>• Overgrazing</li> </ul>	<ul style="list-style-type: none"> <li>• Gully healing/repair</li> <li>• Grass Reseeding</li> <li>• Reforestation</li> <li>• Constructing check dams</li> <li>• Drains Rerouting</li> <li>• Terracing on slopy areas</li> <li>• Gabions</li> </ul>
11	Ewaso 1-4	Ewaso Ngiro river area: 1° 10' 7" S 35° 45' 24" E	<ul style="list-style-type: none"> <li>• Gentle flat &amp; Gentle slopes</li> <li>• Natural seasonal grassland and short</li> </ul>	<ul style="list-style-type: none"> <li>• Livestock keeping</li> </ul>	<ul style="list-style-type: none"> <li>• Sheet erosion</li> <li>• Run-off</li> <li>• Overgrazing</li> </ul>	<ul style="list-style-type: none"> <li>• Grass and tree planting</li> <li>• Rainwater harvesting</li> <li>• Soil conservation activities</li> </ul>

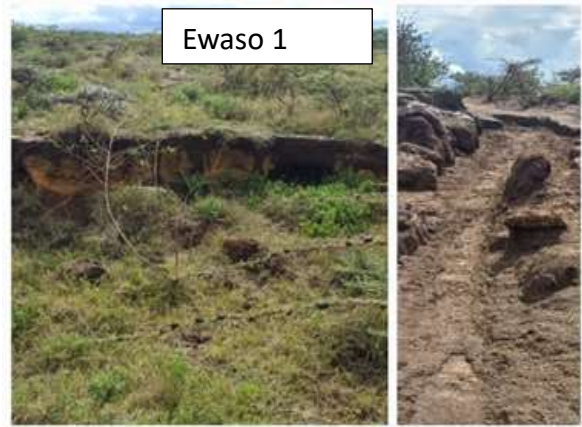
Ewaso 1

Alt. 1843.4m a.s.l.	shrubs with bare ground in some areas • Population is scarce			
12	Ewaso Town	area experience catastrophic floods: 1° 8' 49" S 35° 46' 5" E Alt. 1854.5m.a.s.l.	<ul style="list-style-type: none"> <li>• Gentle and long slopes</li> <li>• Open grassland, shrubs, thorny trees and acacia trees</li> <li>• Population is scarce along the degraded areas but dense around town.</li> </ul>	<ul style="list-style-type: none"> <li>• Livestock keeping</li> <li>• SMEs</li> </ul>	<ul style="list-style-type: none"> <li>• Overgrazing</li> <li>• Deforestation</li> <li>• Reel and gully erosion</li> </ul>	<ul style="list-style-type: none"> <li>• Gully healing/repair</li> <li>• Grass reseeding</li> <li>• Constructing check dams</li> <li>• Drains Rerouting</li> <li>• Terracing</li> <li>• Gabions</li> <li>• Soil conservation activities</li> <li>• Rainwater harvesting</li> </ul>
13	Mulot Twenya Hills	0° 57' 6.6" S 35° 30' 47.5" E Alt. 2050m a.s.l.	<ul style="list-style-type: none"> <li>• Hilly area with natural grass, shrubs, trees.</li> <li>• Steep to very steep slopes</li> <li>• Population is scarce</li> <li>• Loss of grass/vegetation cover in large areas</li> </ul>	<ul style="list-style-type: none"> <li>• Livestock keeping</li> <li>•</li> </ul>	<ul style="list-style-type: none"> <li>• Deforestation</li> <li>• Soil erosion</li> <li>• Overgrazing</li> </ul>	<ul style="list-style-type: none"> <li>• Gully healing/repair</li> <li>• Grass reseeding</li> <li>• Constructing check dams</li> <li>• Drains Rerouting</li> <li>• Terracing</li> <li>• Gabions</li> <li>• Soil conservation activities</li> <li>• Rainwater harvesting</li> </ul>
